# **Condition Assessment of William Beaumont General Hospital Historic Buildings at Fort Bliss, Texas**

Thomas R. Napier and Sheila A. McCarthy

September 2002

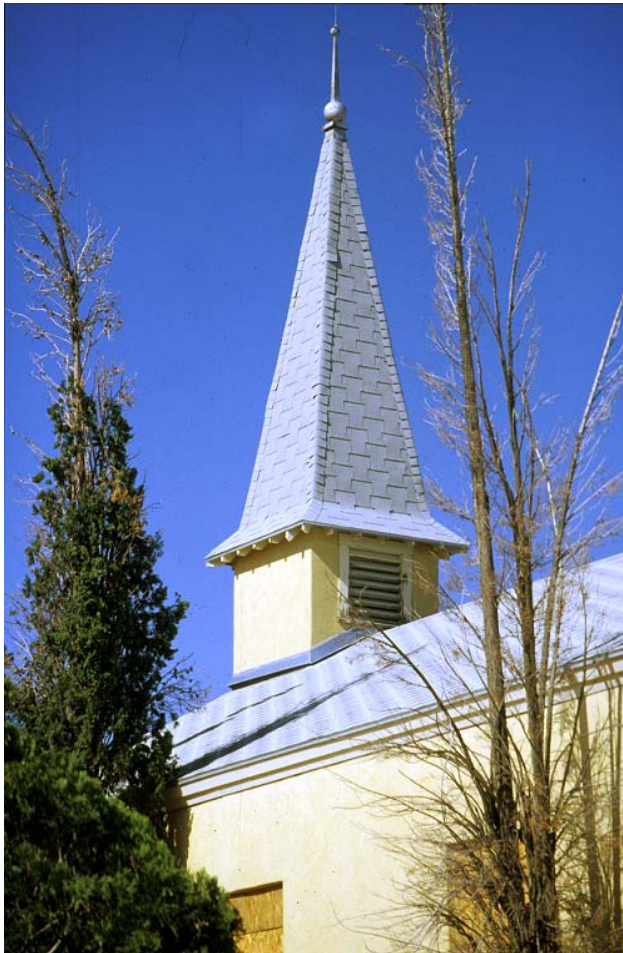
Minor cracking in the stucco is evident at the steeple, and at the east side of the south steeple wall (Drawing 2, C; Photograph 7). A hole has also been drilled in the north wall of the boiler room, and spalling has occurred around a vent hood (Drawing 2, D). These items will have to be repaired during the exterior's refinishing.

Photograph 7. Minor stucco cracking on chapel.

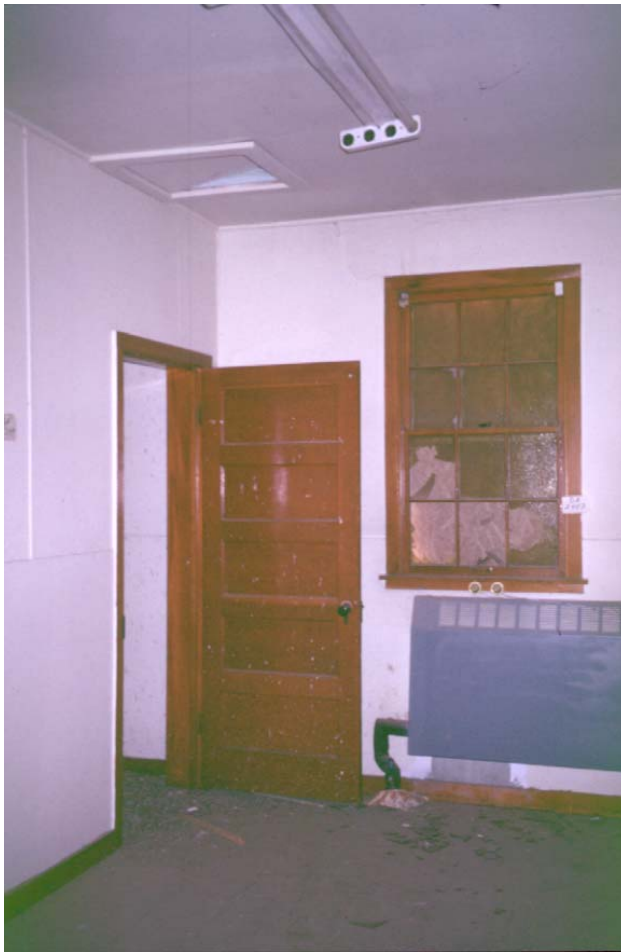
Windows in the foyer areas and sacristy remain in place, although they are boarded on the exterior. They are double hung with six-over-six sashes. In general, they are intact and not seriously deteriorated. Amber colored textured glass appears to be the original glazing material. Many panes have been broken. Some have been replaced with clear glass, and some have not been replaced at all. Serious damage was observed to only two sashes, apparently by vandalism (Drawing 2, E; Photograph 8). It should be possible to repair and refinish these windows. The window below the steeple on the south wall remains unboarded. It is intact, although it will require repair and refinishing.

**Photograph 8. Damaged sacristy window sashes.**

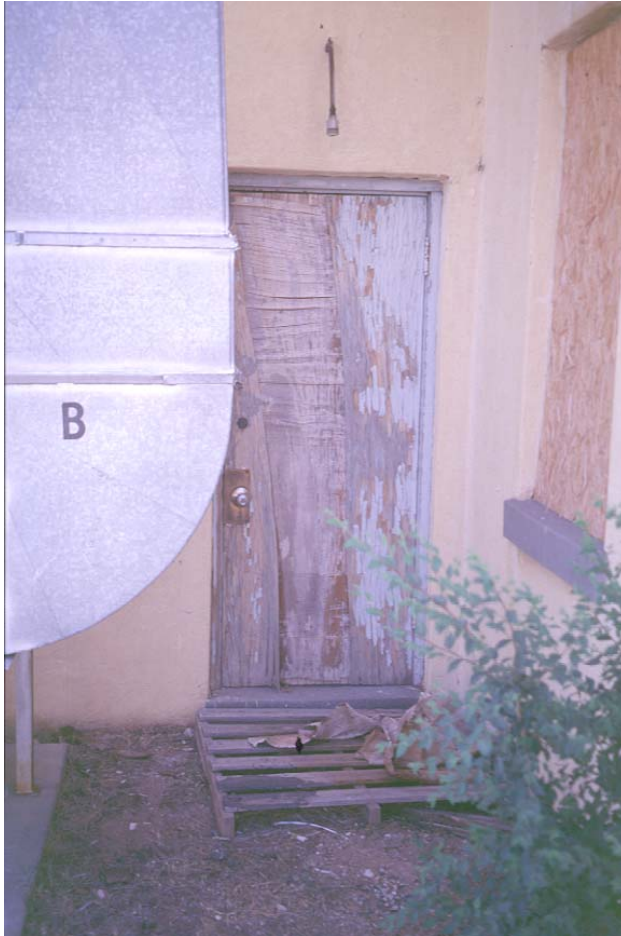
however, they are in poor condition. These doors should be repairable, although it will be more practical to replace them if similar style doors are available through salvage and reuse activities.

**Photograph 9. Deteriorated sacristy door.**

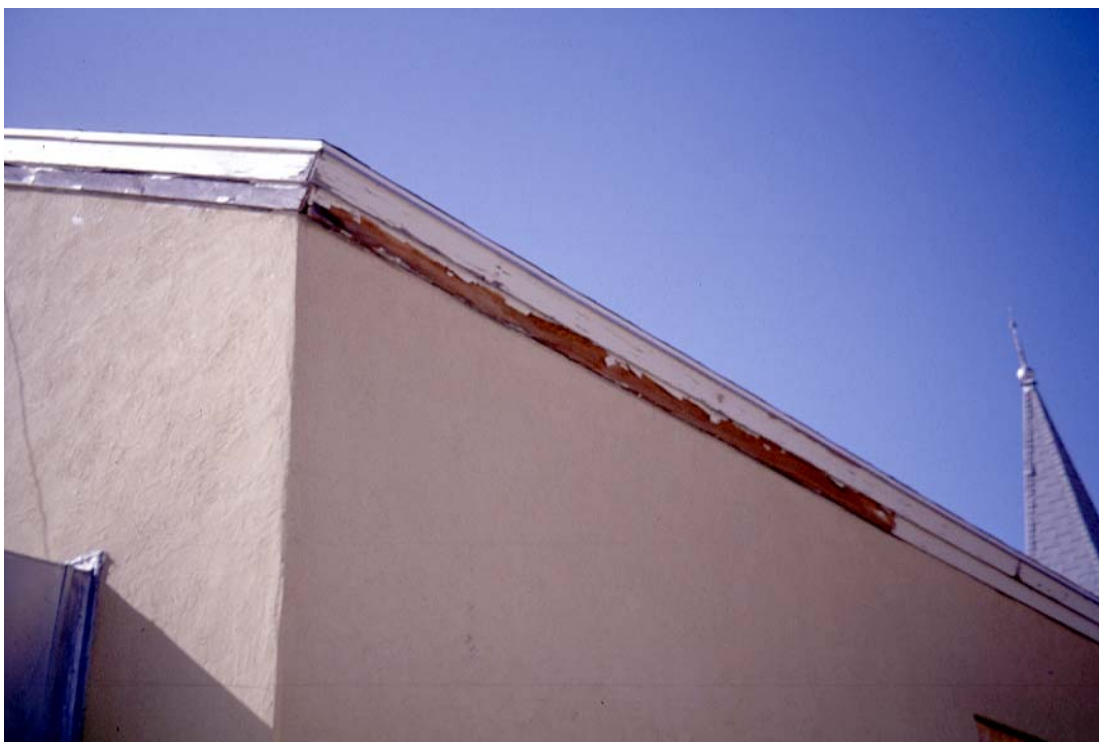
Minor deterioration of the eave trim occurs around the building. For example, paint has failed at the fascia at the north end of the east wall, at the rake trim on the north gable end (Drawing 2, G; Photograph 10), and at the rake trim at the south gable end below the steeple (Drawing 2, H). Scraping, priming, and repainting should be an effective repair.

Photograph 10. Detail of paint failure on chapel trim.

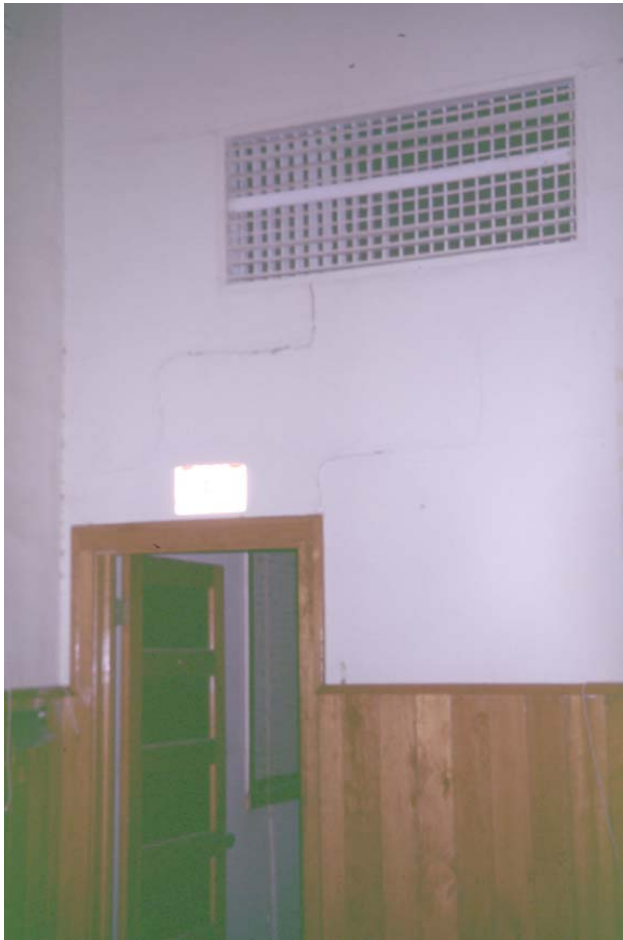
Photograph 11. Minor damage around chapel air conditioning duct.

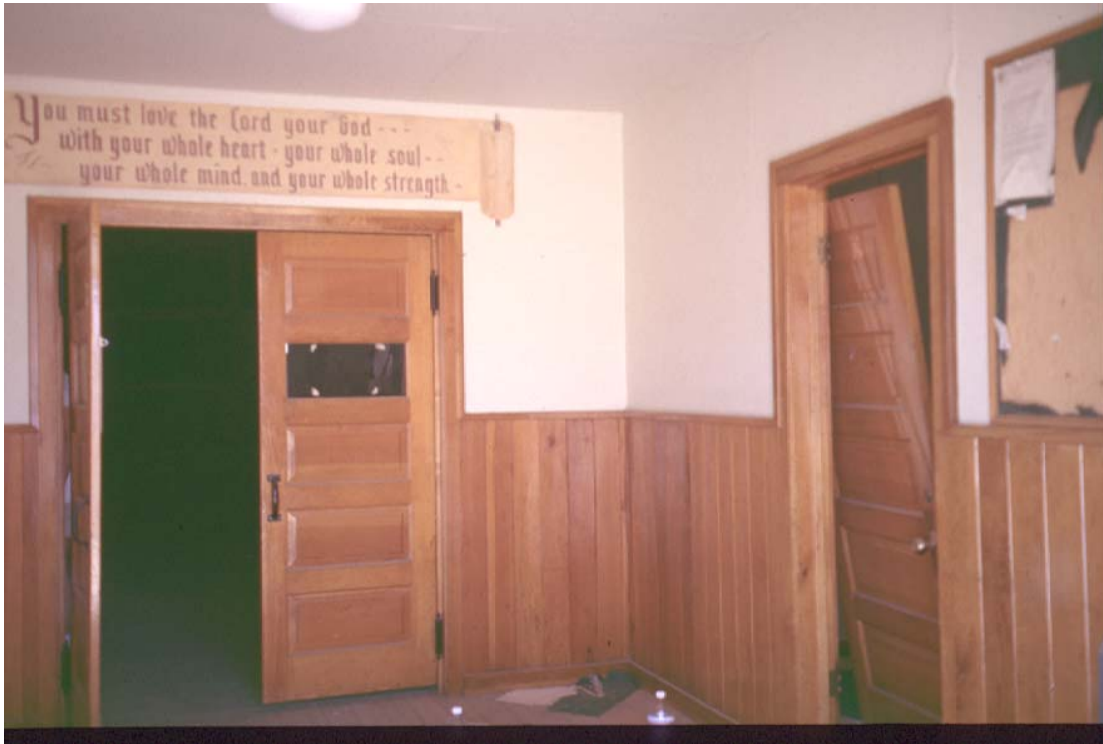
Photograph 12. Damaged chapel lobby door.

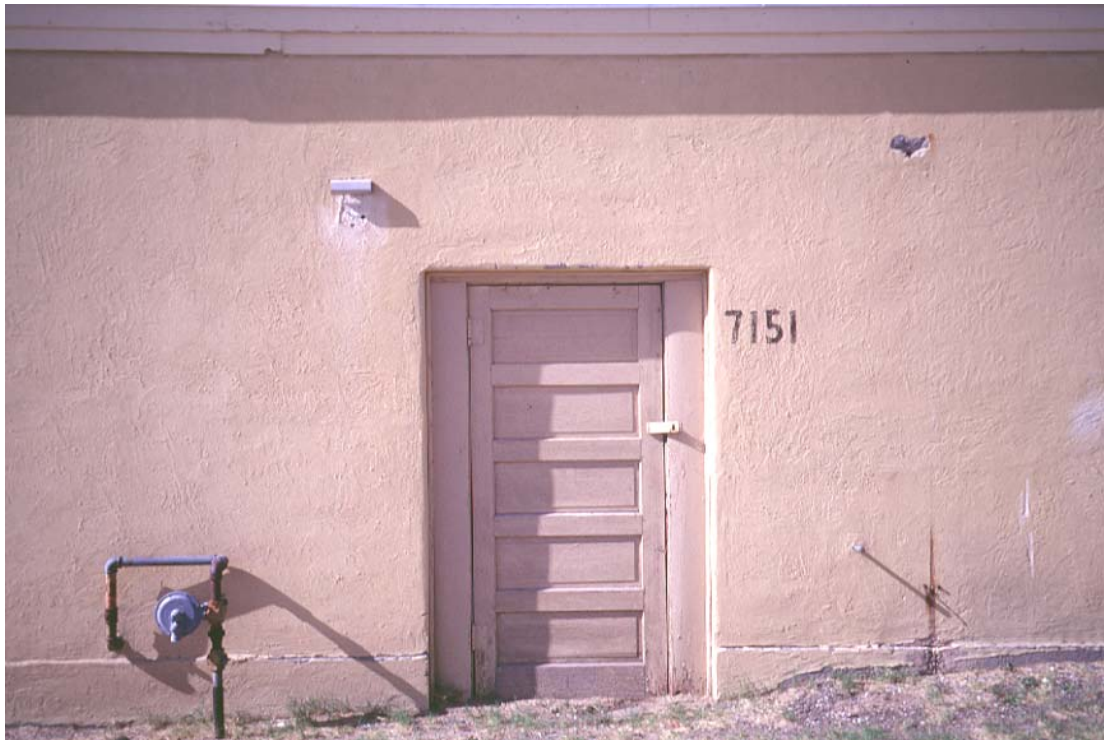
2, S; Photograph 14). No damage from water intrusion was evident in the building's floor or wall finishes near the floor. However the crawl space vents at the building's northwest corner were almost closed by the coarse soil carried by runoff, indicating runoff is entering the crawl space. Regrading to ensure positive drainage away from all sides of the buildings should be included as part of the adaptive use design.

Photograph 14. Chapel site drainage detail.

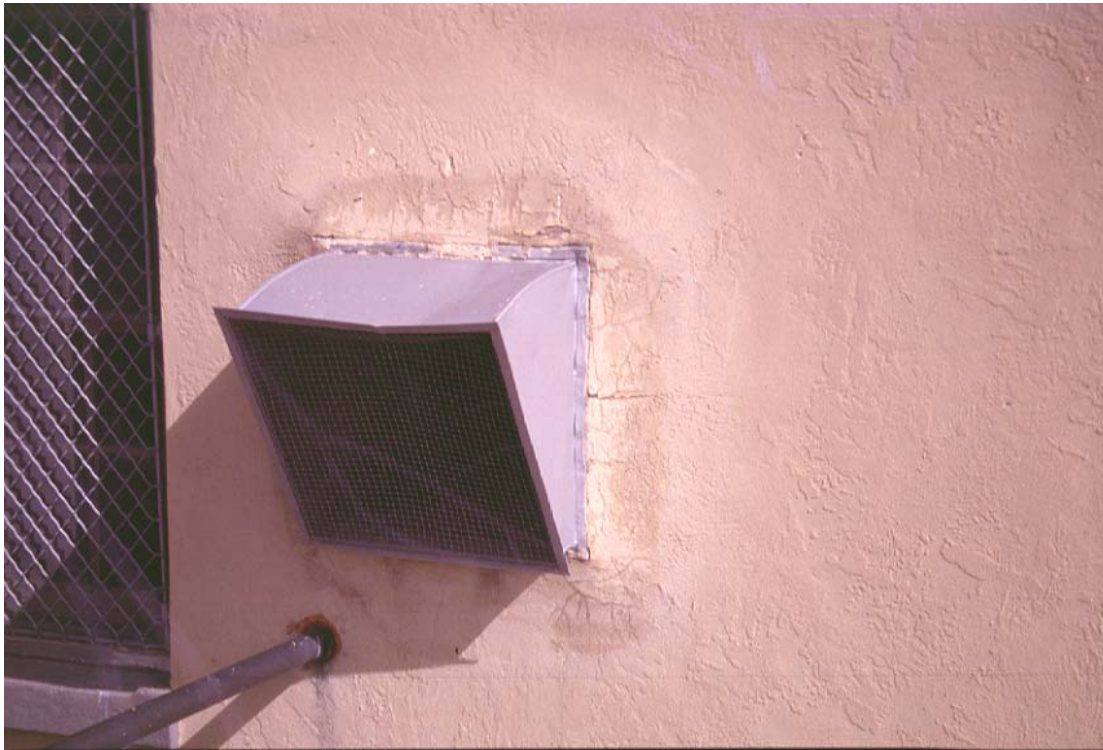
The exterior walls are in generally good condition. Minor cracking occurs around a metal vent hood at the north wall (Drawing 3, E; Photograph 16), around a light fixture over the east exit (Drawing 3, F), at pipe penetrations at the east wall (Drawing 3, G), and around the south exit at the west wall (Drawing 3, H). Louvers and grills on the north wall will require minor repair and refinishing. These repairs should present no problems when refinishing the exterior.

Photograph 16. Minor theater wall cracking around vent hood.

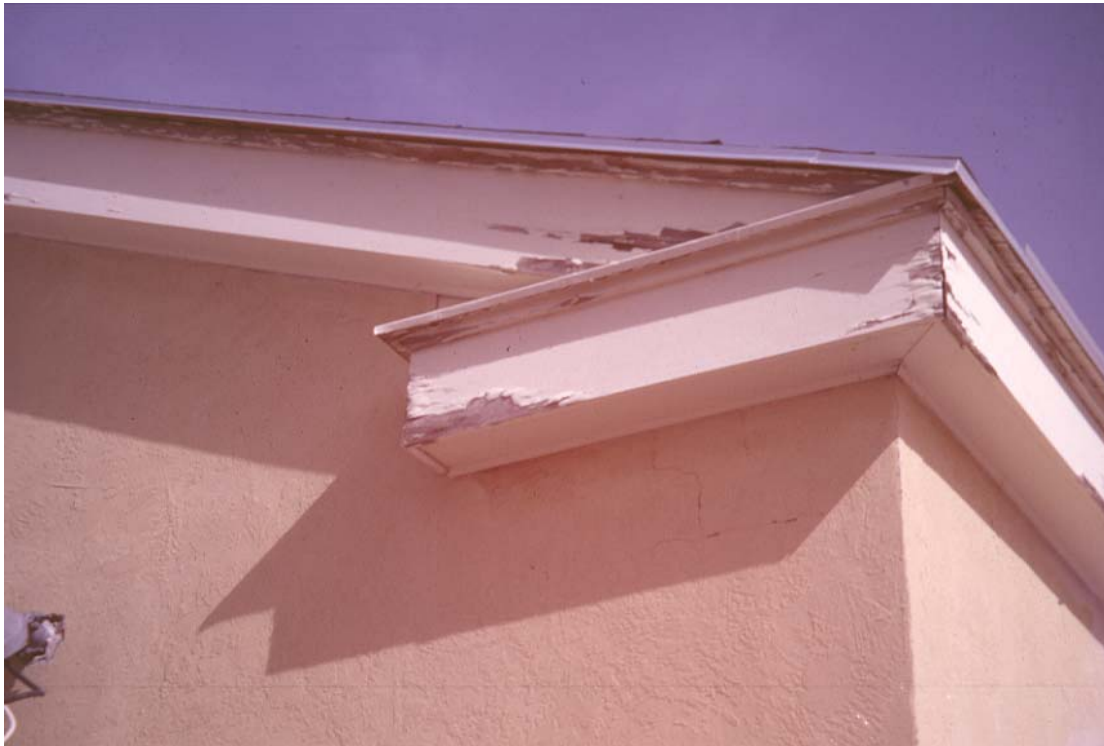
Some minor deterioration is evident in the eave trim (Photograph 17). Splitting has occurred in the rake board at the west end of the north eave, and in the fascia board at the north end of the west eave. Also, the fascia around the porch roof over the entry is badly peeled. However, scraping, filling, priming, and painting should be sufficient to rehabilitate these areas.

**Photograph 17. Deterioration of theater eave trim.**

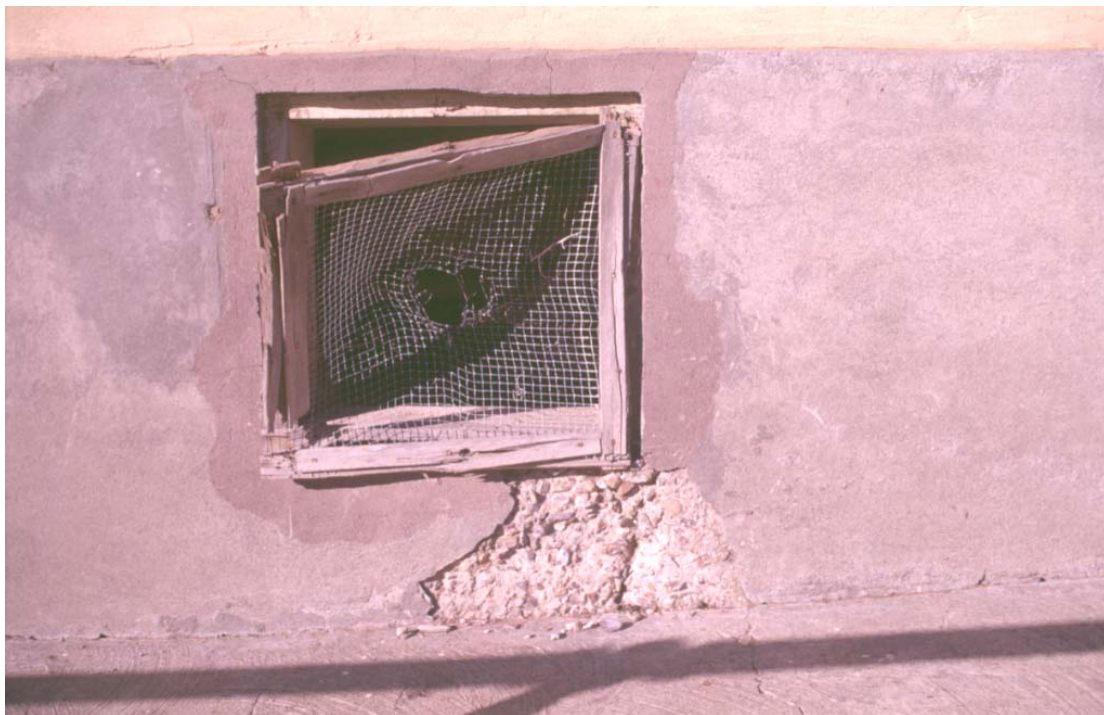
Minor cracking occurs throughout the foundation. A crack appears at the east wall, tracing from the lower corner of a crawl space vent, through the wall, and into the foundation (Drawing 4, A; Photograph 20). However, no differential movement or settlement was evident. This minor cracking should be sealed as part of the exterior refinishing. As the cracking appears to have not progressed for some period of time, repair should remain effective.

**Photograph 20. Minor gymnasium foundation cracking.**

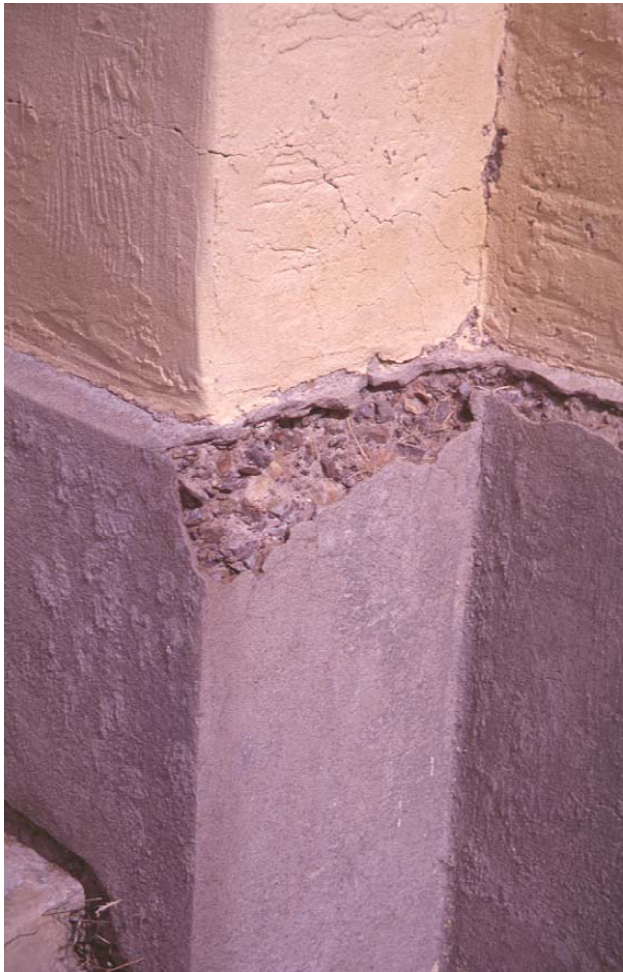
Concrete has spalled at the tops of two foundation pilasters on the north side of the building, adjacent to the loading dock (Photograph 21). Minor cracking in the wall pilasters was observed, although no settlement has occurred.

**Photograph 21. Minor gymnasium pilaster cracking.**

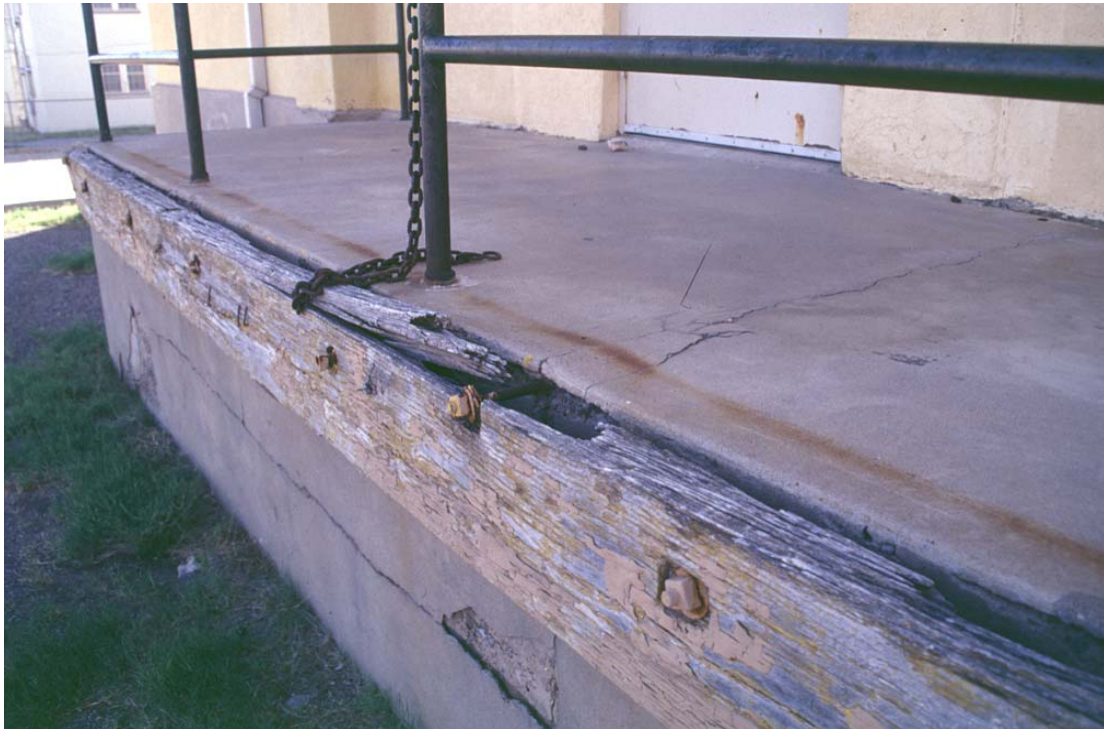
Cracks are present throughout the loading dock (Drawing 4, B). The deck slab is badly cracked, especially at the corners where the pipe railing has rusted and spalled away the concrete (Photograph 22). The slab is also deteriorated around the edges where anchor bolts held wood bumpers. The bumpers themselves are almost totally deteriorated, and the anchor bolts are exposed. Impact from vehicles may also have contributed to cracking and eventual deterioration. Repair of the loading dock may be possible, although replacement may be more feasible.

**Photograph 22. Concrete damage on gymnasium loading dock.**

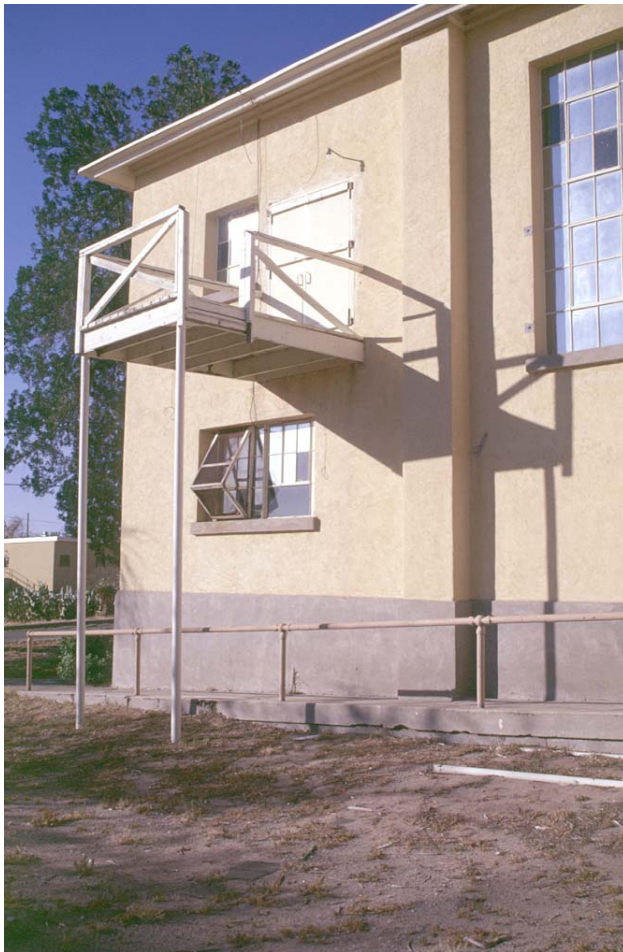
A fire escape stair structure has been added to the south end of the east wall (Drawing 4, F; Photograph 23). The stairs have been removed, but the tower structure remains. It is assumed that this structure will be removed and replaced in a rehabilitation design. The damage to the wall from the structure's anchor bolts will have to be repaired.

**Photograph 23. Unused gymnasium fire escape tower.**

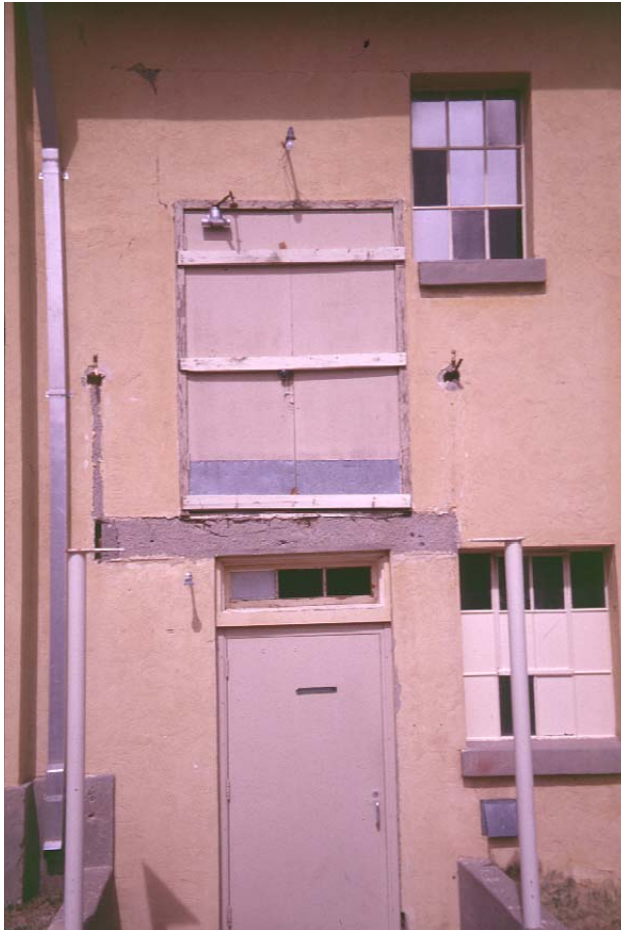
structure will be replaced in some fashion in a rehabilitation design. The damage to the wall from the removed structure will have to be repaired.

**Photograph 24. Gymnasium wall damage where fire escape was removed.**

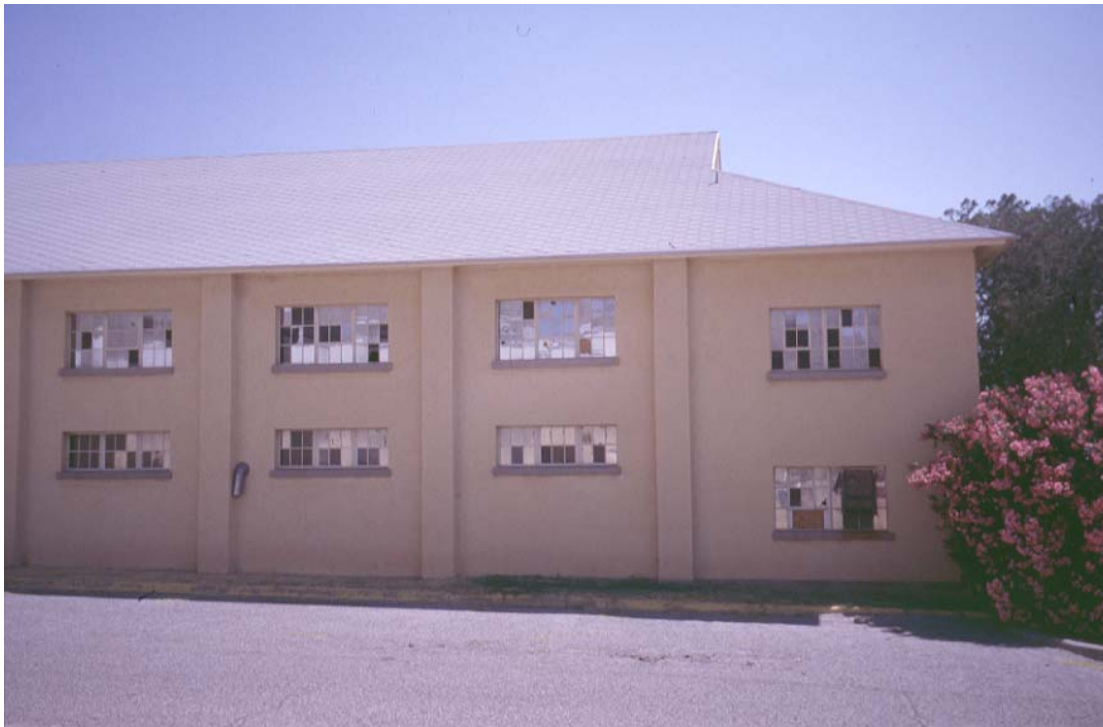
Reflective film has been installed on the glass panes. At present, many of the panes have been replaced without replacing the film (Photograph 25). In a rehabilitation or reuse design, film should be either restored to all glazing, or should be removed altogether.

**Photograph 25. Inconsistent use of film on gymnasium windows.**

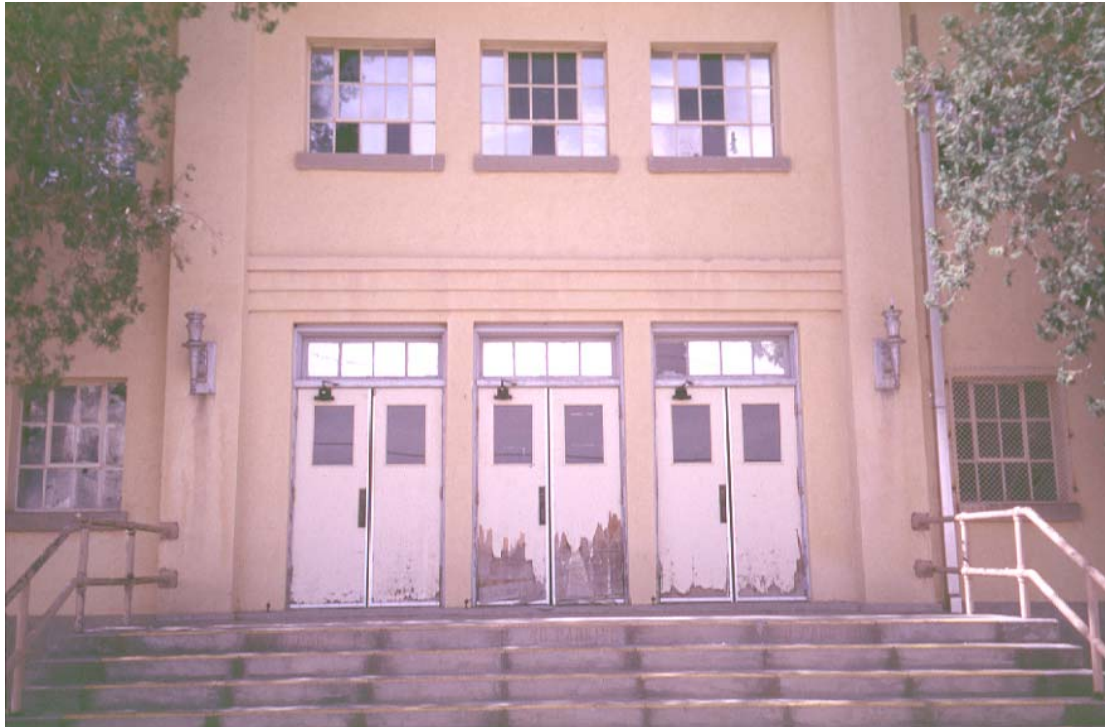
The triple sets of double-leaf doors at the south entry are a significant element of the original south elevation (Drawing 4, I). The doors have been replaced with flush wood doors, which are seriously deteriorated (Photograph 26). These will have to be replaced with a historically appropriate style of door. Two-panel doors are depicted on the original drawings. The transoms above the entry doors are intact, although repair and refinishing will be necessary.

**Photograph 26. Deteriorated gymnasium entry doors.**

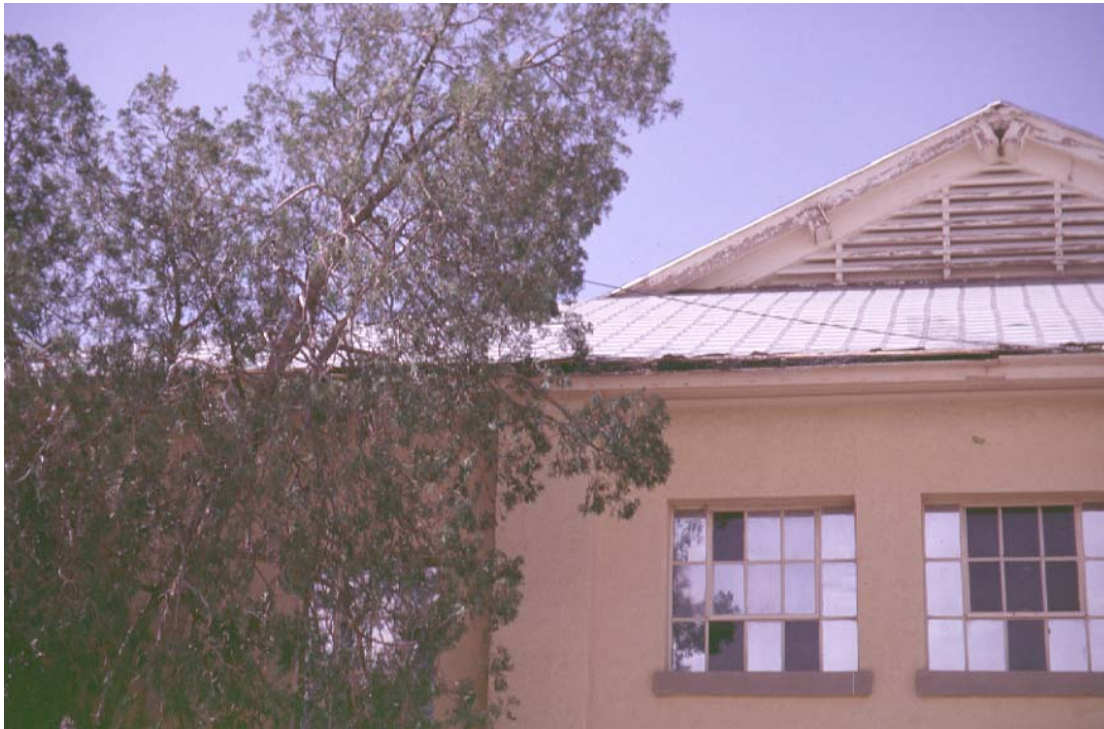
There is serious damage at the south eave (Drawing 4, J) caused by tree branches that overhang the south hip at the building’s corners and are abrading the roofing (Photograph 27). Damage has occurred to both the roofing and the eave trim. The roofing in this area will have to be replaced, and the eave trim repaired and refinished. The louver at the south hip will also require scraping, priming, and painting.

**Photograph 27. Gymnasium roof abrasion.**

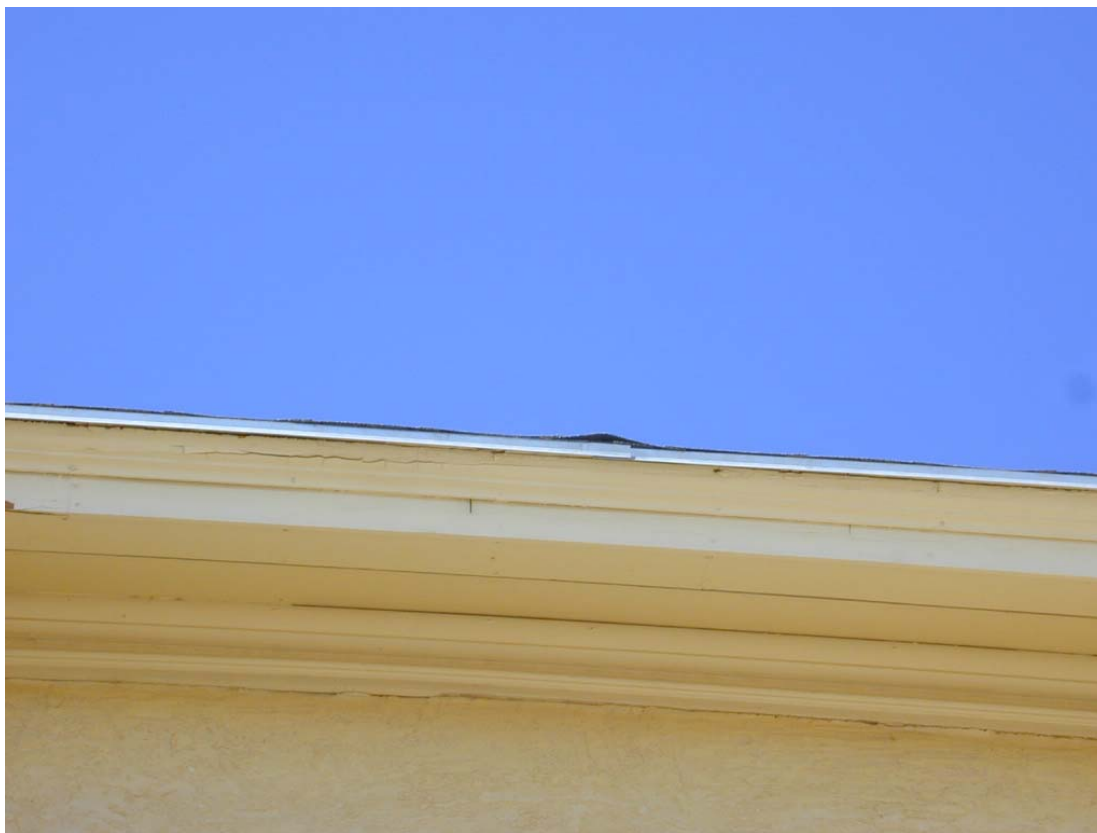
Some fish-mouthing is evident near the east and west eaves (Drawing 4, K, Photograph 28). That is, some shingles are bent so they are not laying flat upon the roof deck or the shingles below them. The metal edge flashing of the roof sheathing is also damaged in one location on the east side (Drawing 4, L). In addition, some shingles are missing at the south end of the ridge (Drawing 4, M).

**Photograph 28. 'Fish-mouth' shingle warpage on gymnasium gable.**

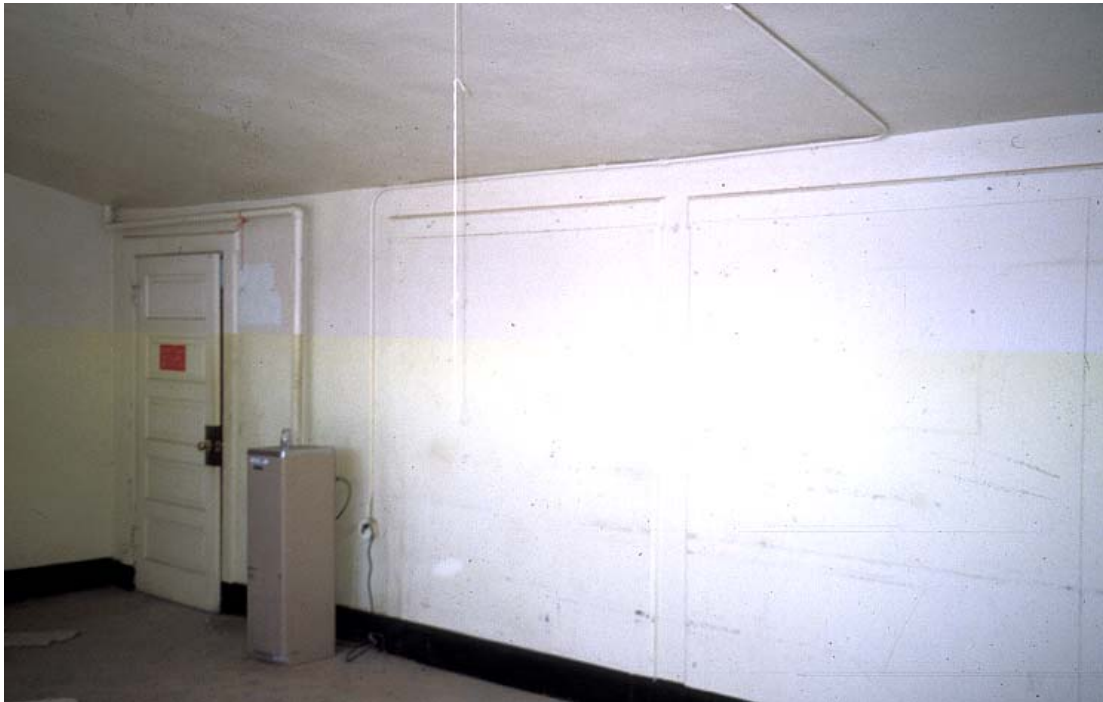
The single door from the lobby to the gym and the north locker room door remain intact. The others have been removed and the openings filled (Drawing 4, P). Padding is installed on the gym walls. The door trim remains, although it has been painted. These portals, especially the former entrance from the lobby, are significant elements in the building's design (Photograph 30). It would be possible to restore these doorways if historically appropriate replacements can be found for the doors. In deciding such a rehabilitation measure, items such as the building's future occupancy, must be considered, especially with regard to the building's function, safety, and circulation.

**Photograph 30. Historically incompatible modifications of gymnasium locker room portal.**

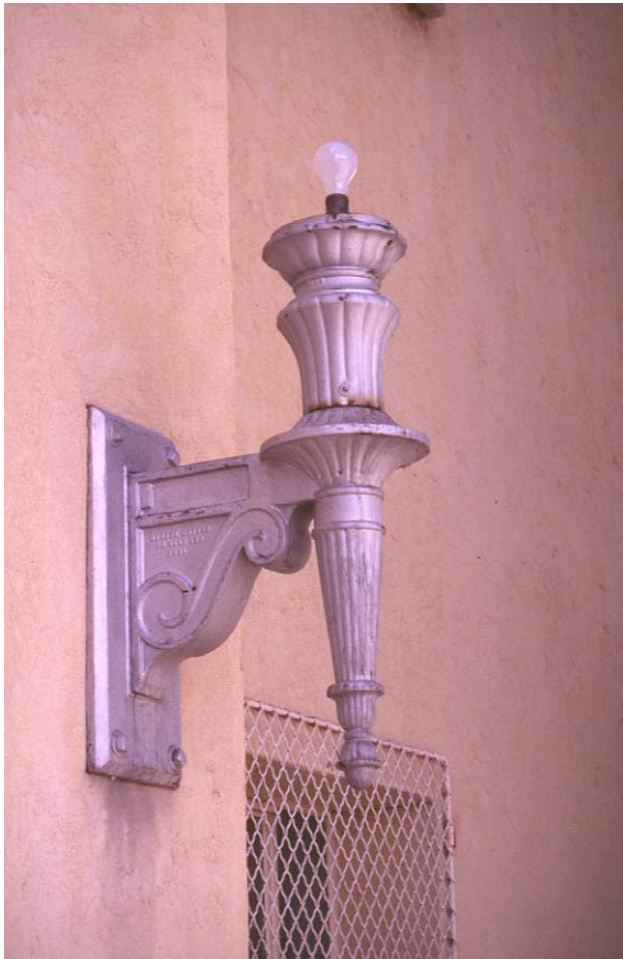
Two ornamental exterior light fixtures flank the entry at the south side of the building (Drawing 4, X). The glass globes have been removed (Photograph 31). As they are the only ornament on the building's exterior, they assume some significance to the building's original design. These fixtures should be able to be upgraded and refinished as part of the exterior restoration.

Photograph 31. Exterior gymnasium light fixtures with globes missing.

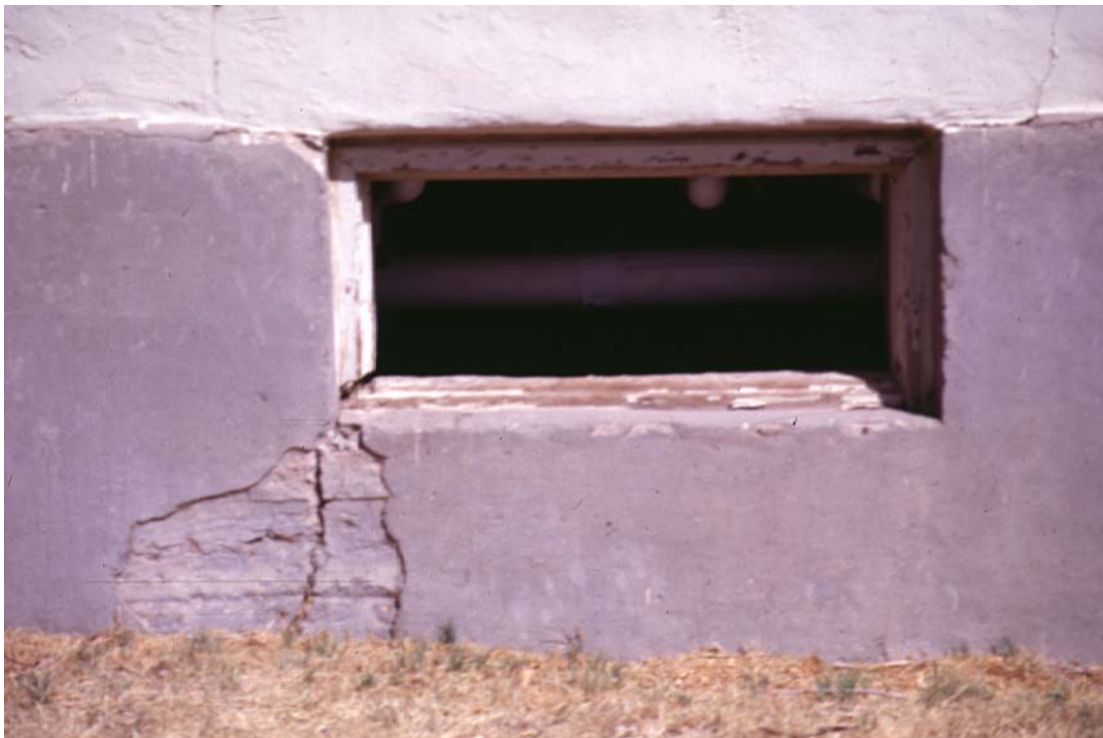
Some concrete parging is spalling away from the foundation on the south side of each building. A crack has also opened up at the lower corner of the south crawl space access opening of each building (Drawings 5 – 7, A). There does not appear to be any differential settlement. As this crack appears to be stable, filling and sealing as part of the exterior refinishing should be an effective repair (Photograph 33).

**Photograph 33. Detail of minor barracks foundation damage.**

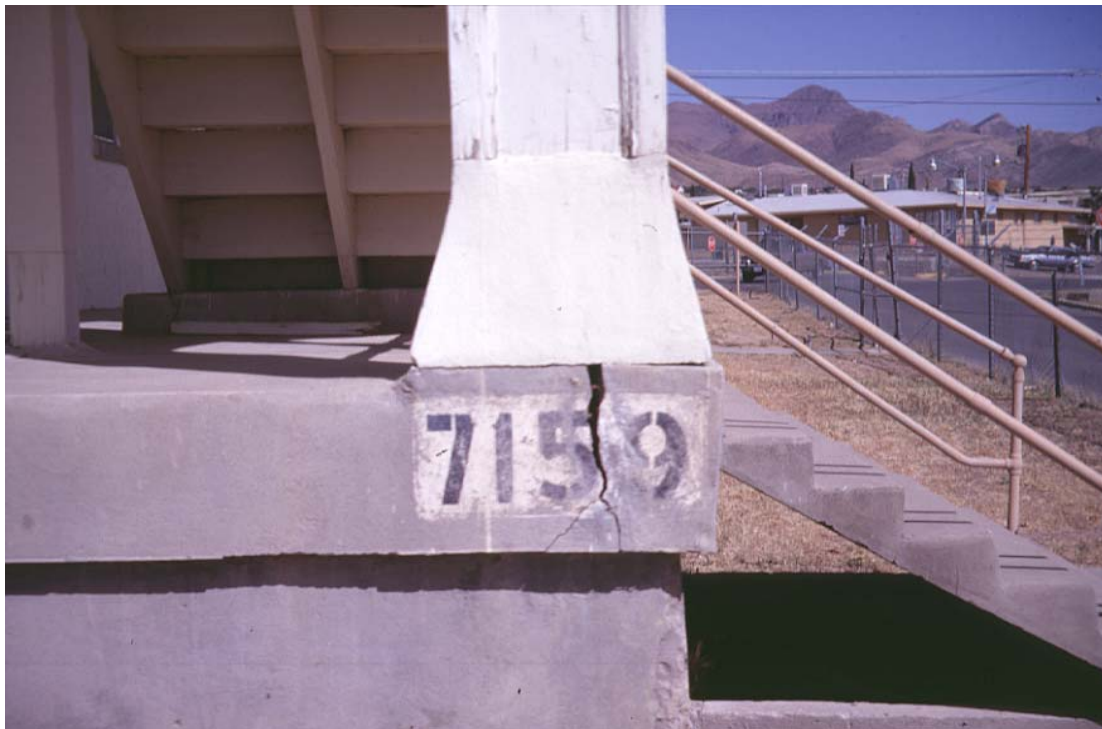
Original drawings depict a framed floor for the porch. The wooden floor has been replaced with concrete slab on all three buildings. The porch columns bear on the concrete slab at the porch's first floor. Significant cracking has occurred in each building at the exterior corners of the floor slab, at the corner columns of the porch (Drawings 5 – 7, C; Photograph 34). As a result, the corner is breaking away from the slab. No such cracking is evident at the other columns.

**Photograph 34. Detail of barracks porch slab cracks.**

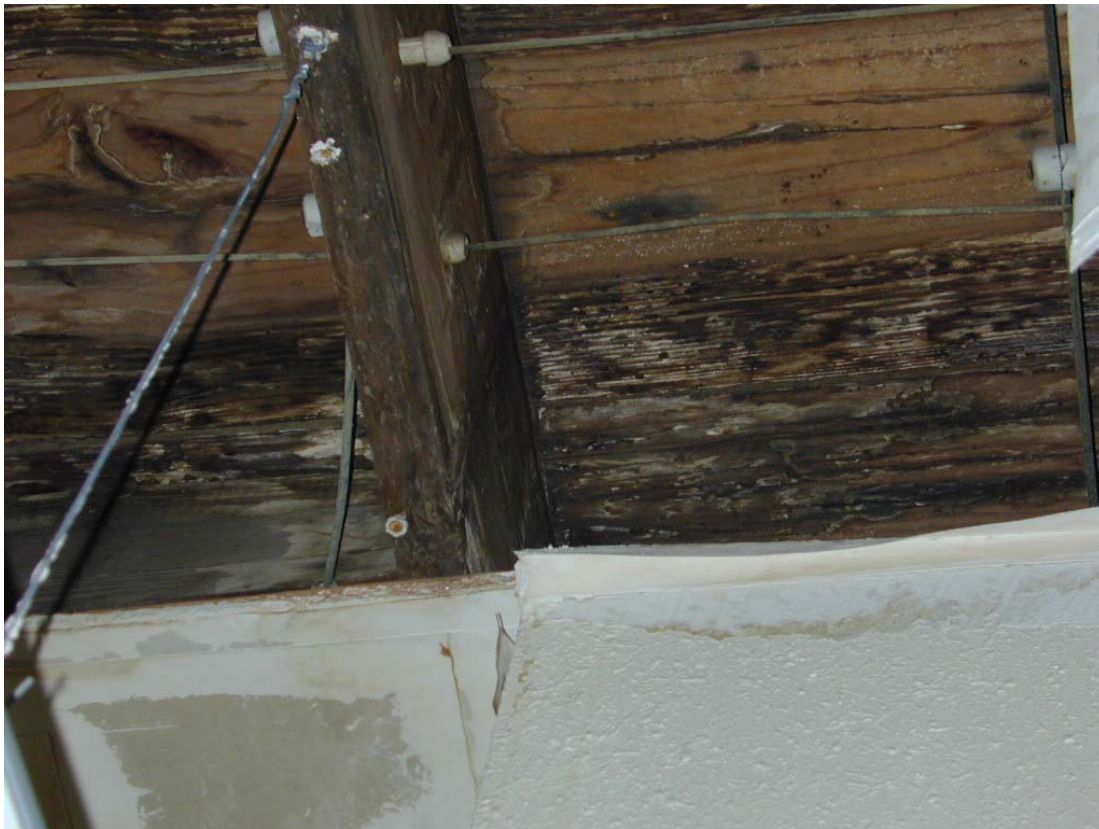
Water damage is evident in the first floor washroom ceilings of each barracks building, indicating leakage from the washroom fixtures (Drawings 5 – 7, D; Photograph 35). Staining is evident on the floor joists and decking. However, no excessive bounce or sponginess in the washroom floors was evident, although the concrete topping at the original latrine would minimize this behavior. As part of a rehabilitation and reuse design, the floor framing in these areas should be checked for potential water damage and deterioration.

**Photograph 35. Water damage from leaking barracks washroom fixtures.**

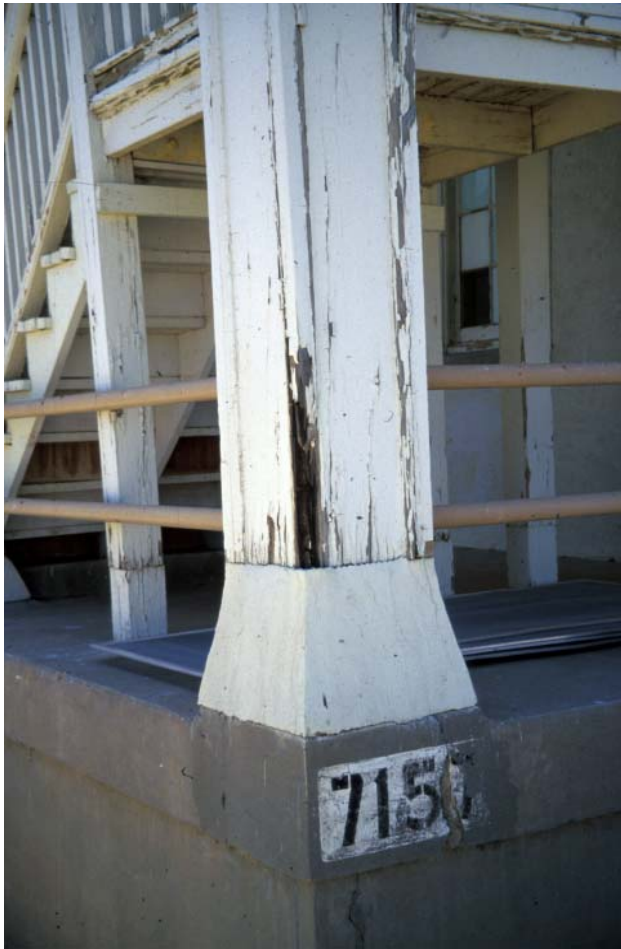
**Photograph 37. Water-damaged stucco detail on barracks porch column.**

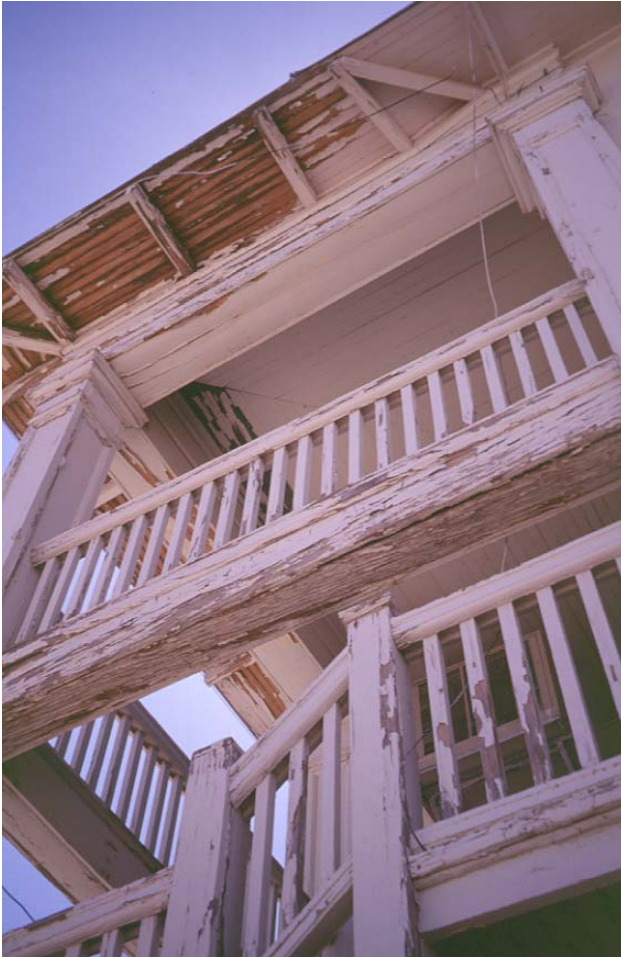
Extensive water damage is evident in the eaves at the north and south ends of all three porches, above the stairwells (Drawings 5 – 7, E; Photograph 38). As part of rehabilitation or reuse design analysis, the roof framing and porch column assemblies in these areas will have to be evaluated for deterioration. See the discussion under "Roofing," page 86. The eaves in the middle sections of each porch, however, are considerably less deteriorated.

**Photograph 38. Typical water damage to barracks porch roof.**

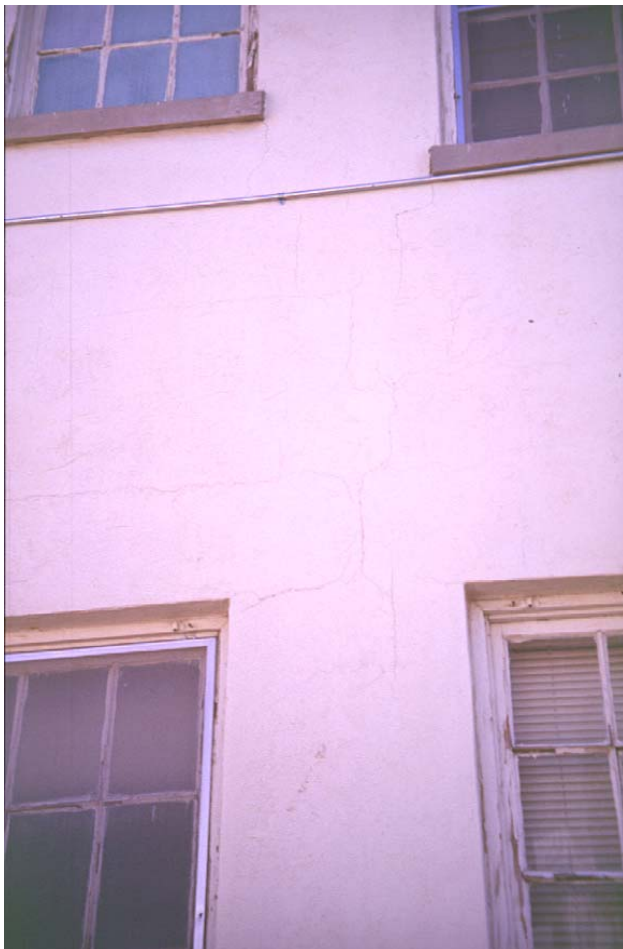
Minor cracking also occurs on the west wall of each building, at the first and second floor washrooms. The cracks follow the block joints (Photograph 39). Leakage into the block from the plumbing fixtures' overflowing may have contributed to weakening the stucco. This cracking should also be repaired as part of the exterior's refinishing.

Photograph 39. Typical minor stucco damage on barracks exterior.

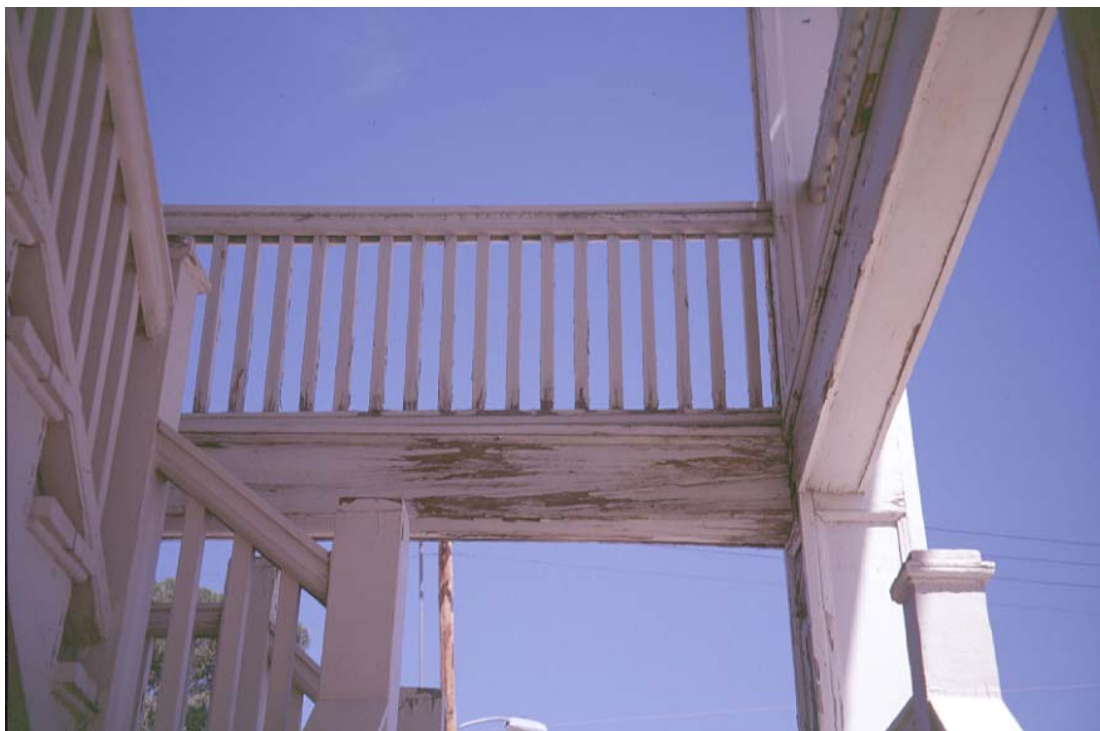
The exterior trim enclosing the porches' structural members is seriously deteriorated, especially at the stairwells at the north and south ends of the building (Drawings 5 – 7, F; Photograph 40). Painting has apparently been neglected for some time. Many, if not most, of the trim boards are severely split and warped. Many baluster pieces are missing. While some of the original trim may be repairable, extensive replacement probably will be necessary. The stucco "base" detail should be replaced to restore the original detail and prevent water accumulation.

**Photograph 40. Typical deteriorated exterior trim on barracks.**
